Our Ref: SS128

Date: 22 May 2018

STRUCTURAL REPORT

DENHAM VILLAGE HALL, HOXNE ROAD, DENHAM IP21 1PN

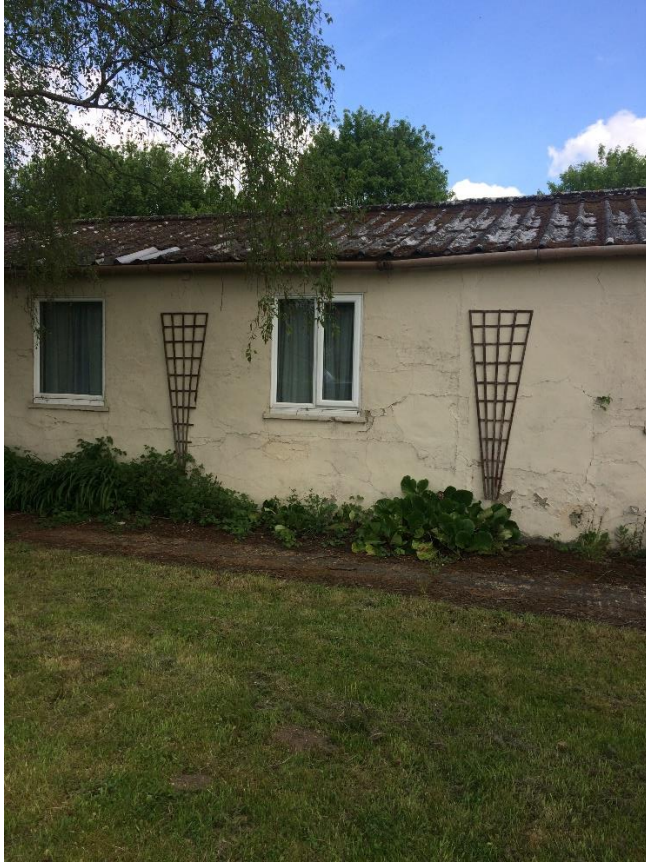
Photo 1-part front elevation

- 4.1.1 Externally the visual appearance of the building is extremely poor. The external applied render has cracked, and sections of the render are falling away. Other sections have been poorly repaired by applying a patch render over loose render which has again worsened the appearance of the render and building as a whole. On the front right-hand corner there is evidence of a small plant growing through the render from the internal face.
- 4.1.2 The right-hand gable end, as faced from the driveway, has been re-rendered but

- 5.1 On first review the building appears in appalling condition. Close inspection shows no signs of major structural failure or movement. The cracking observed, which is widespread to external walls of the building façade, is mainly due to the render cracking and parting from the brickwork structure.

- 5.7.a All cementitious render to be stripped off to expose the underlying brickwork outside brick. Piers still in place which have deteriorated should have the badly eroded/ frost shattered bricks removed, and new bricks cut in and re-mortared.

- 5.7.d New external protective render needs to be applied but this should have a break within it and a bell drip above ground level, so that the render does not proceed down to ground level; so, there is a break at 150 mm above ground level and a damp-proof injection zone created which should then create a damp proof course

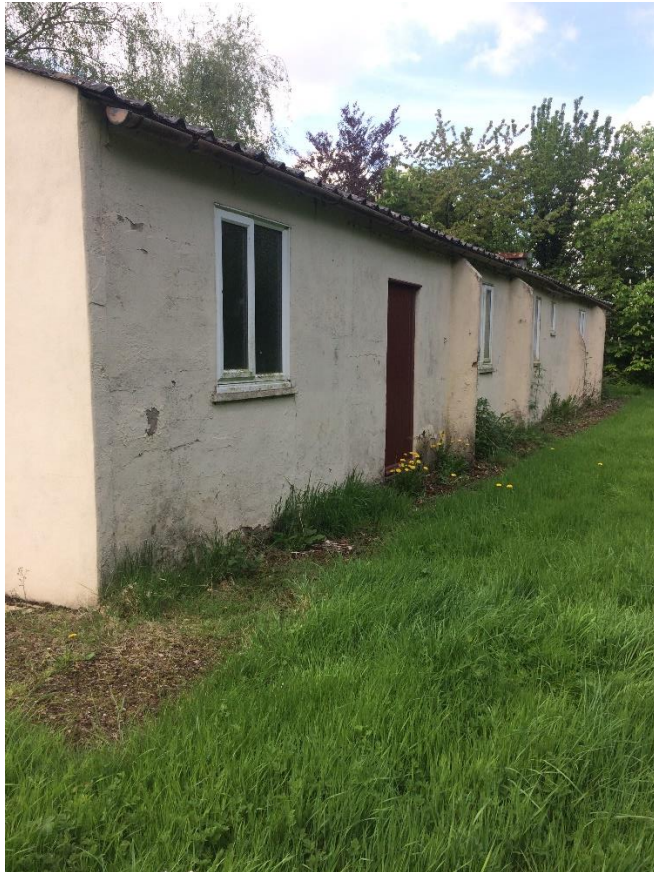
Photo 2 rear elevation

- 4.1.3 The rear elevation appears much as the front elevation, with sections of render dropping away and many sections being loose which will deteriorate rapidly.
- 4.1.4 The right-hand gable is much as the left-hand gable with the render in poor condition.
- 4.1.5 The roof profile is straight and even with the exception of the far-left hand gable, where the ventilation box has sagged locally.

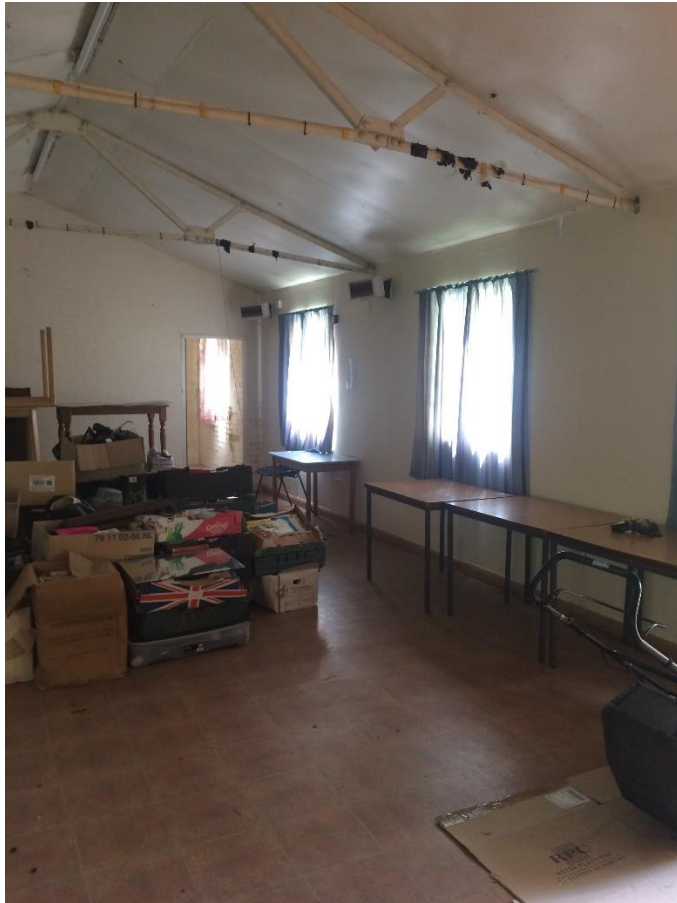
Photo 3 typical internal view

- 4.2.3 The main hall room front and rear walls are board-lined, so the masonry could not be reviewed, and the ceiling has an under-lining finish of a board which has started to sag, and this is probably due to damp and condensation issues with lack of insulation to the roof sheeting over.
